**Facility Condition Assessment Services**

**Facility Condition Assessment**

**For  
City of Los Altos  
Senior Center  
97 Hillview Avenue  
Los Altos,  
CA 94022-3740**

**Date of Report: June 10, 2016**

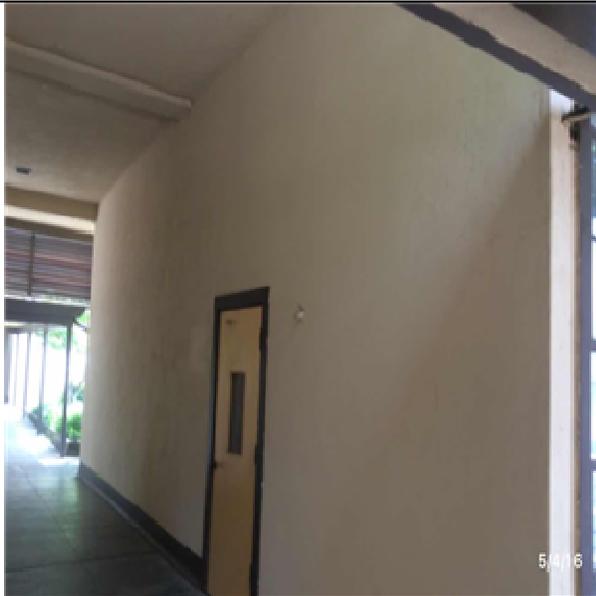
The wall construction was observed to be in fair condition and well maintained; there are no instances of deterioration, cracking or damage observed. Therefore no actions will be generated during the study period for works associated with the structural wood frame structure.

B2011 Exterior Wall Construction:- View of Stucco over stud walls

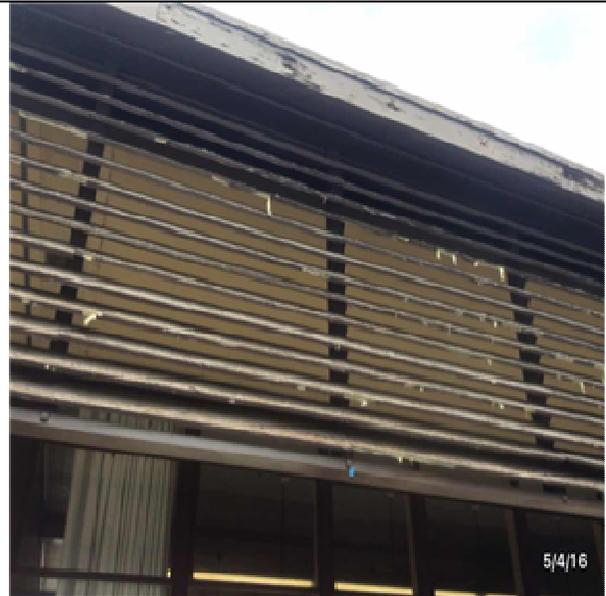
B2014 Exterior Sun Control Devices:- View of Exterior Sun Control Louvers

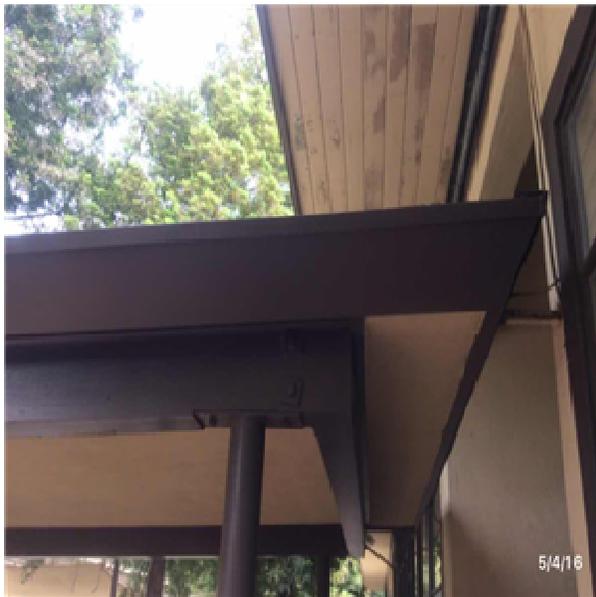
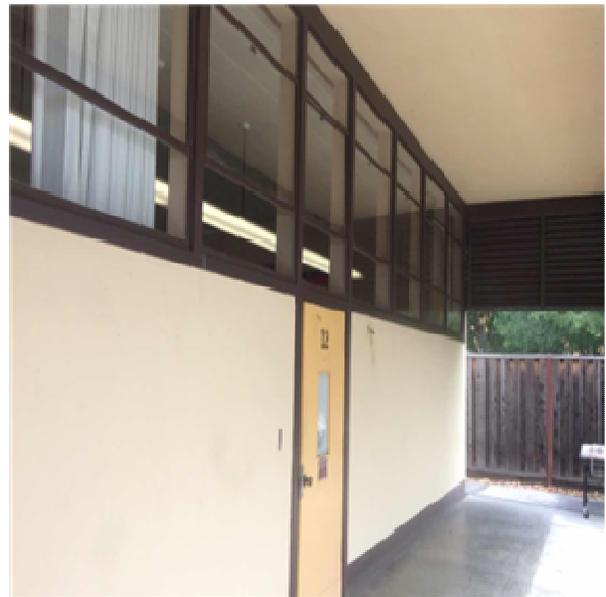
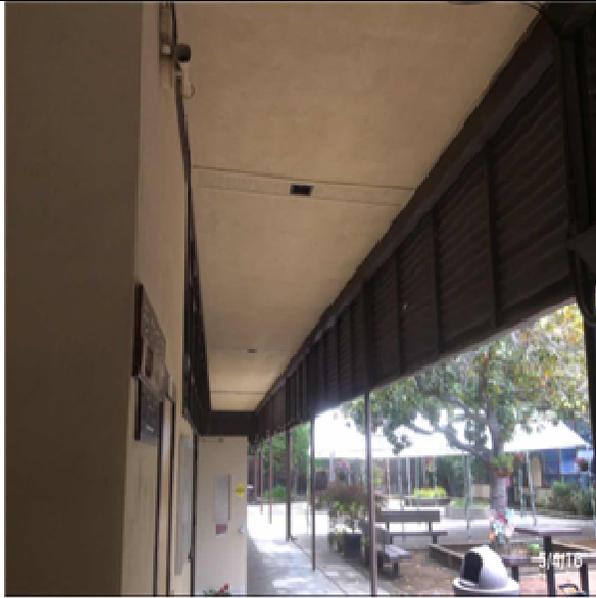
The exterior soffits appeared to be in fair condition; therefore we do not anticipate any actions during the study period. We do however recommend repainting of these surfaces later in the study period to maintain the appearance of the building and also protect the asset.

B2016 Exterior Soffits:- View of Exterior Soffits

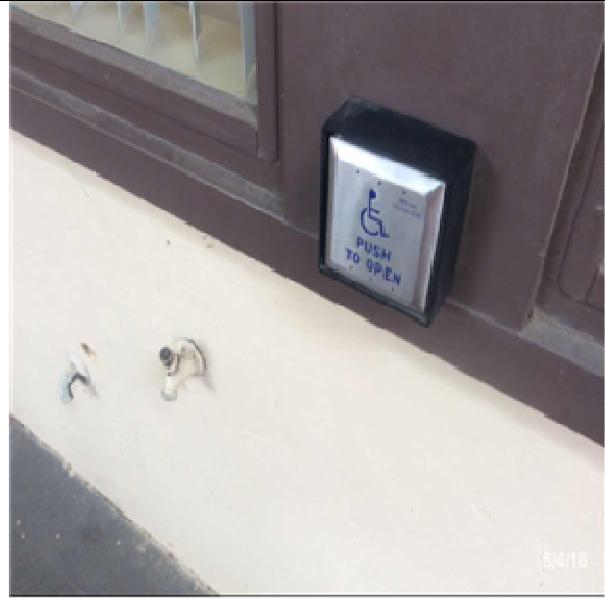
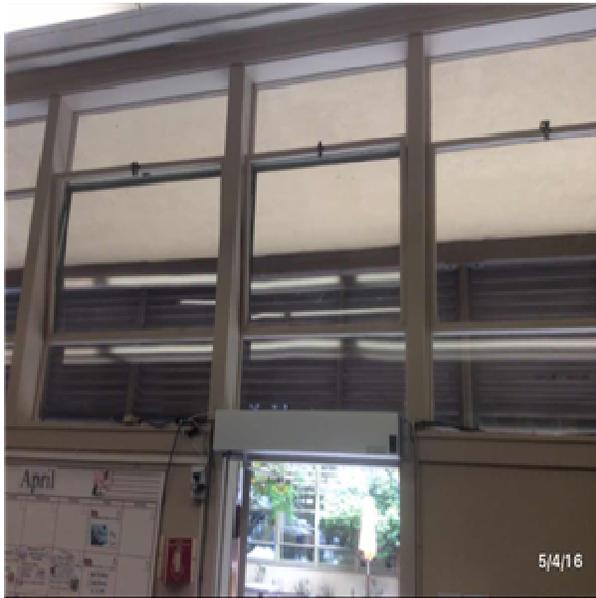
The single swing door appeared to be in fair condition. It operated satisfactory with the hardware performing as required; however, the ADA compliant door openers typically have a EUL of ten years and the existing door will need replacement, therefore we recommend replacement of the entire door and automation later in the study period to maintain adequate access.

B2031 Glazed Doors & Entrances:- View of Single or double automated swing doors

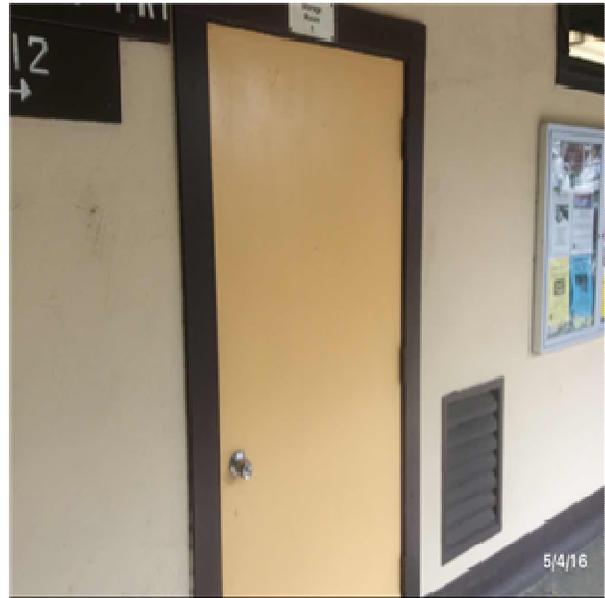
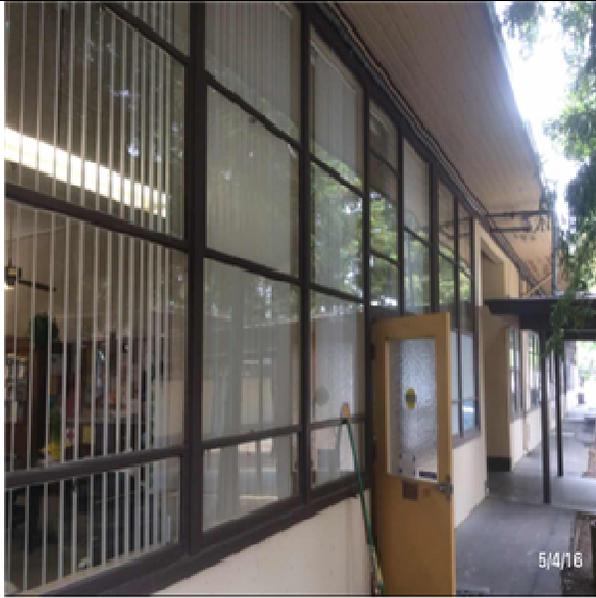
The wood doors at the building were observed to be in poor to fair condition. We have assumed the doors to be original based on the current condition, which would put the doors well past their useful life. Some doors have been repaired but there are signs of degradation. We recommend replacing the doors immediately in order to maintain the appearance and security of the building as well as prevent water penetration. The new door surface finish and door frames will require repainting later in the study period. The cost of this work has been included within the amount to undertake the repainted of the exterior walls.

B2032 Solid Exterior Doors:- View of Exterior Single Solid Core Wood Doors

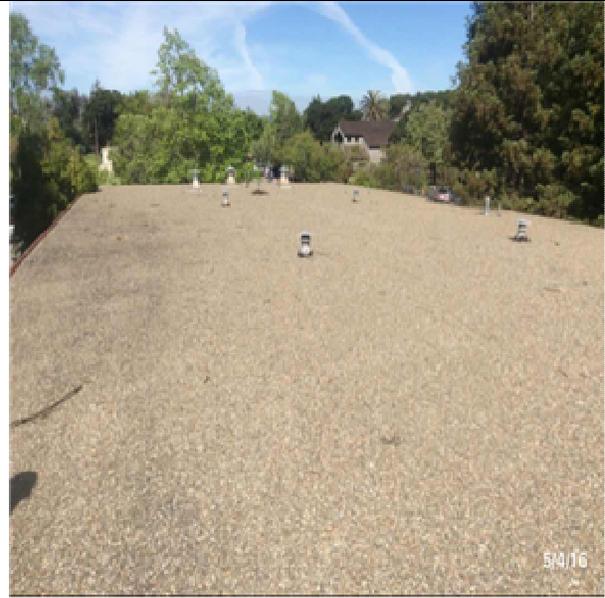
The BUR covering appeared to be in poor to fair condition with no reported leaks, however there is deterioration due to age and other similarly aged roofs to the Community Center have already been repaired. We are unaware of the age of the roof covering, however we assume it to be more than fifteen years of age, therefore based on the typical EUL of twenty years for this type of covering and current observed condition, we anticipate replacement early in the study period.

B3011 Roof Finishes:- View of BUR (Built-up Roofing) Covering

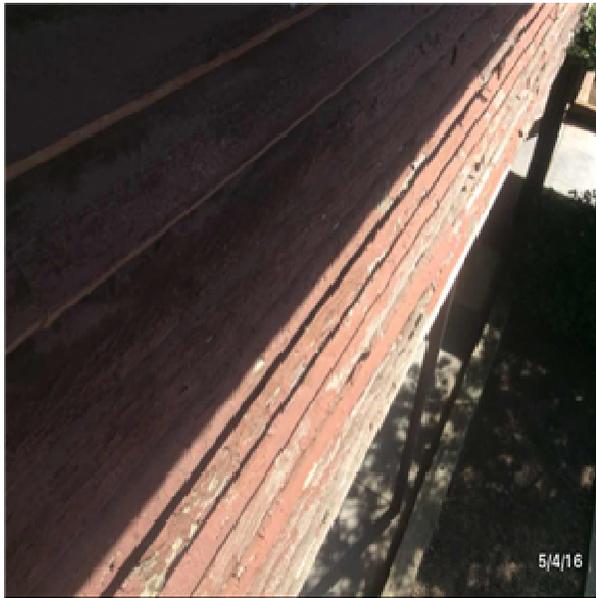
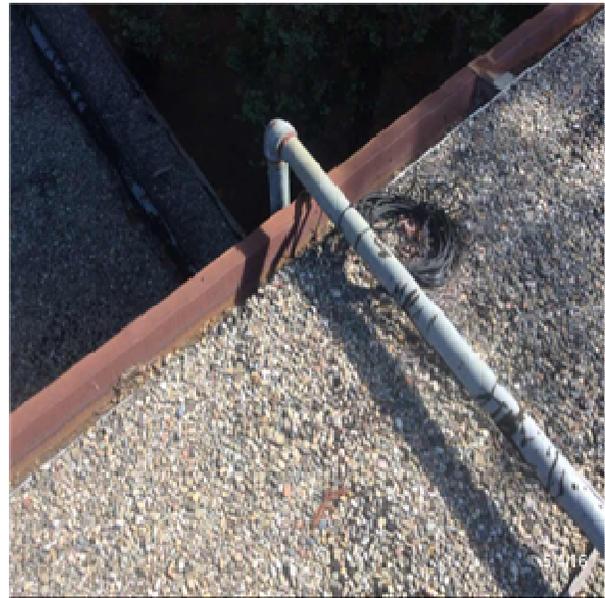
The gutters appear in poor condition. Maintenance personnel reported that the gutters and down spouts are difficult to maintain due to the fact that they are connected directly to the below ground drainage. The typical EUL for this type of gutter system is twenty years; therefore, we recommend replacing the gutters and downspouts at the beginning of the study period.

B3016 Gutters and Downspouts:- View of Galvanized Steel Perimeter Gutters & Downspout

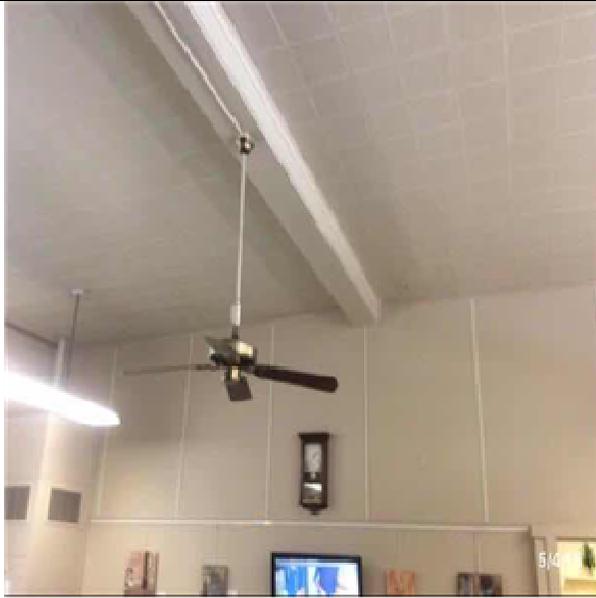
The wall construction is not visible due to its location, however, there are no instances of deterioration, cracking or damage observed. Therefore no actions will be generated during the study period for works associated with the fixed partitions

C1011 Fixed Partitions:- View of Stud Walls with Board Finish

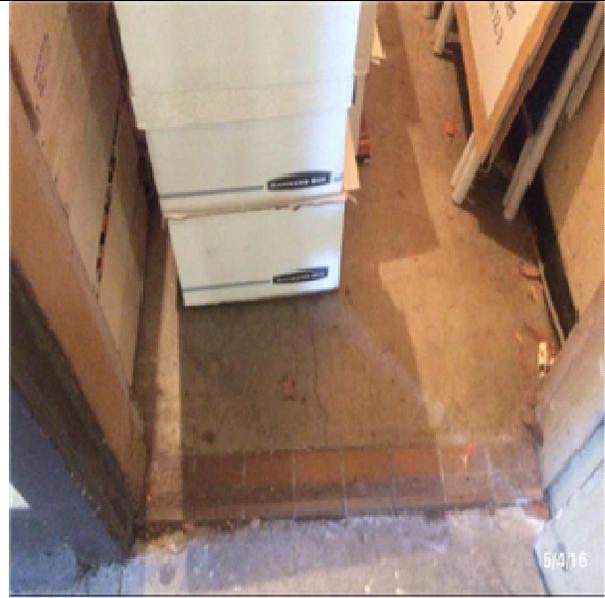
The floor finishes appeared in poor - fair condition throughout the building. We are unaware of the age of the epoxy floor covering at the storage areas, however we assume it to be more than fifteen years of age, therefore based on the typical EUL of ten years for this type of covering and current observed condition, we anticipate replacement early in the study period. The ceramic tile at the restroom was in fair - poor condition given its age. The vinyl tile have a EUL of eighteen years; however, considering the observed condition, we have extended the RUL on this flooring to later in the study period. The ceramic tile has a EUL of thirty years. We did not observe any broken or loose tiles or missing grout; therefore, we expect the ceramic tile to last beyond the study period.

C3023 Hardeners and Sealers:- View of Epoxy Floor Coating

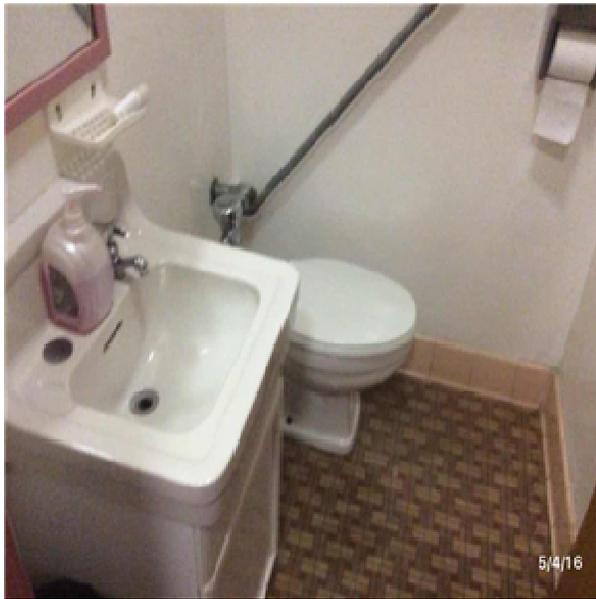
C3024 Flooring:- View of Ceramic Tile

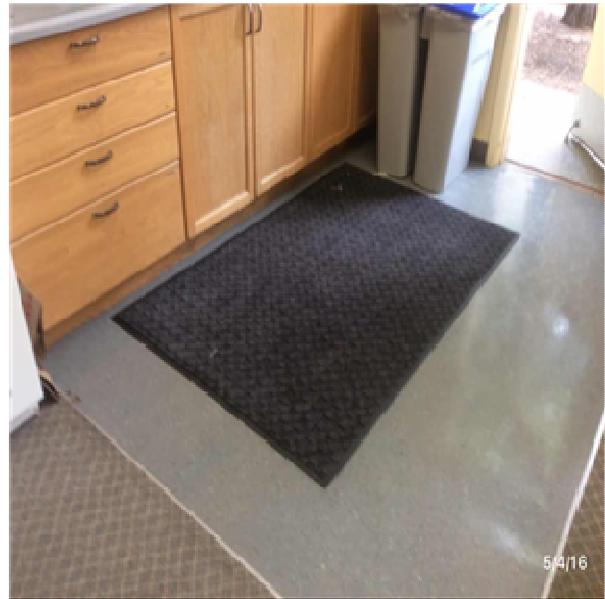
C3024 Flooring:- View of Vinyl Composite Tile (VCT)

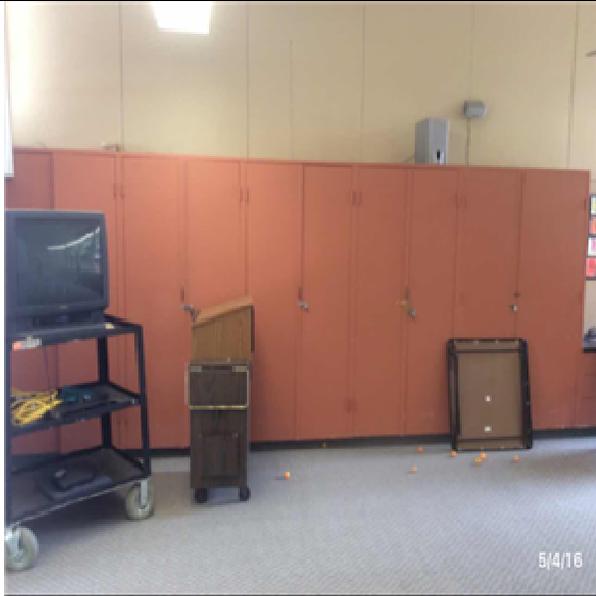
C3025 Carpeting:- View of Broadloom Standard without Padding

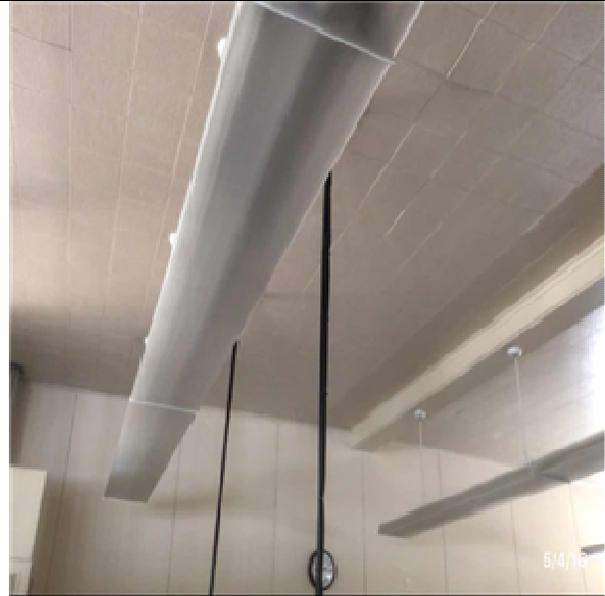
C3032 Suspended Ceilings:- View of Acoustic Ceiling System - Standard

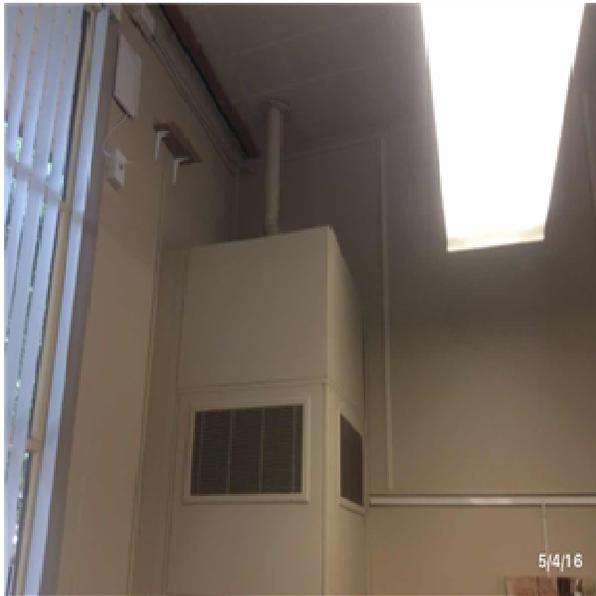
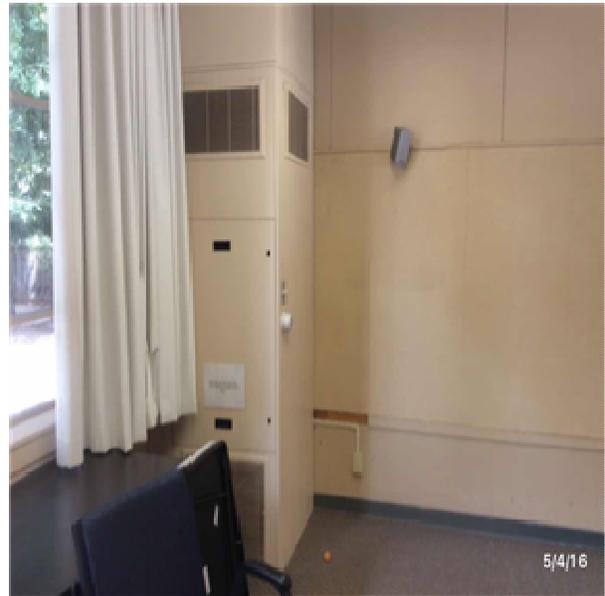
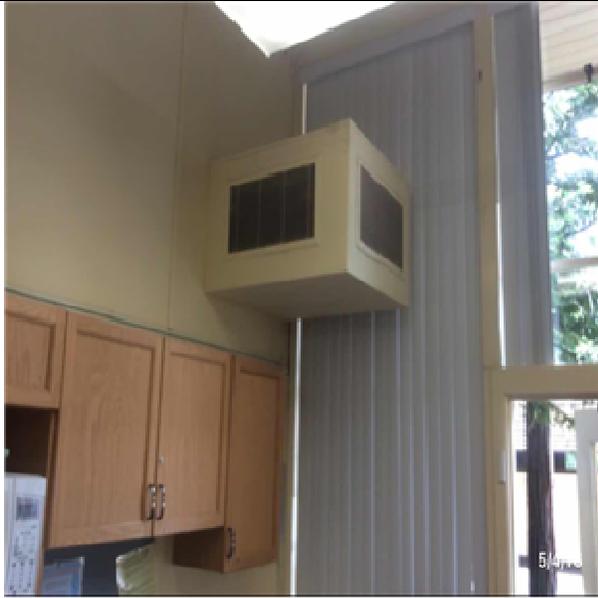
D3021 Boilers:- View of Furnace - Gas

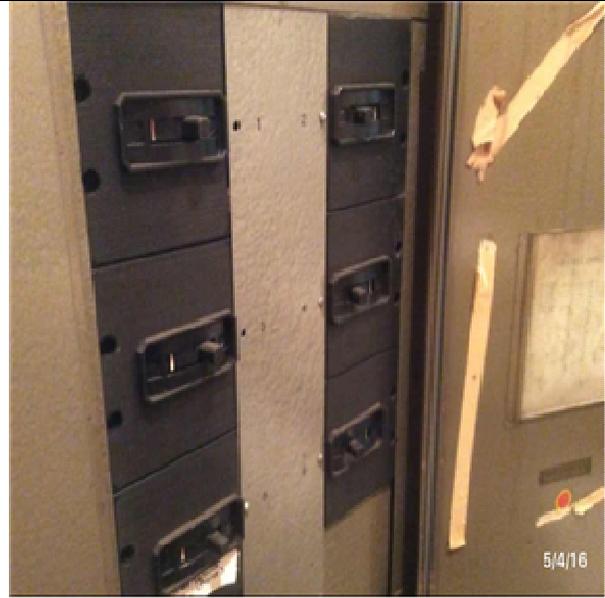
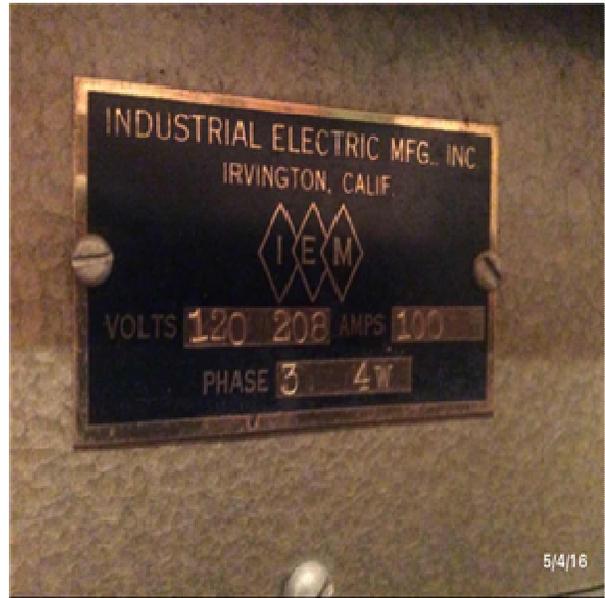
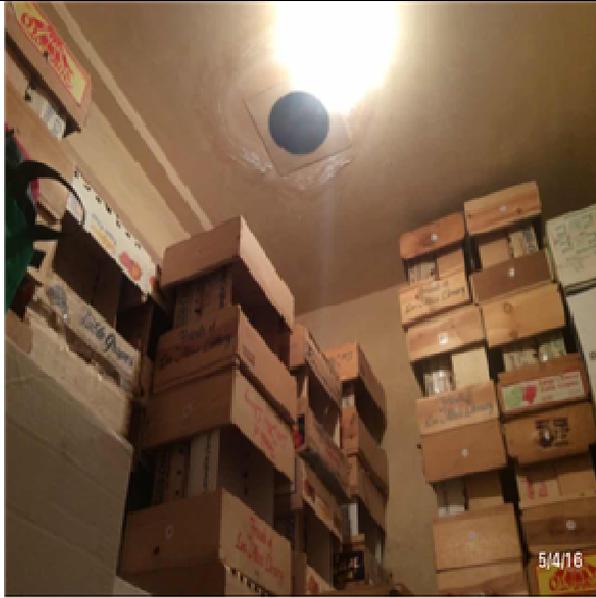
D5012 Low Tension Service & Dist:- View of Panelboard -  
120/208volts, 100amp

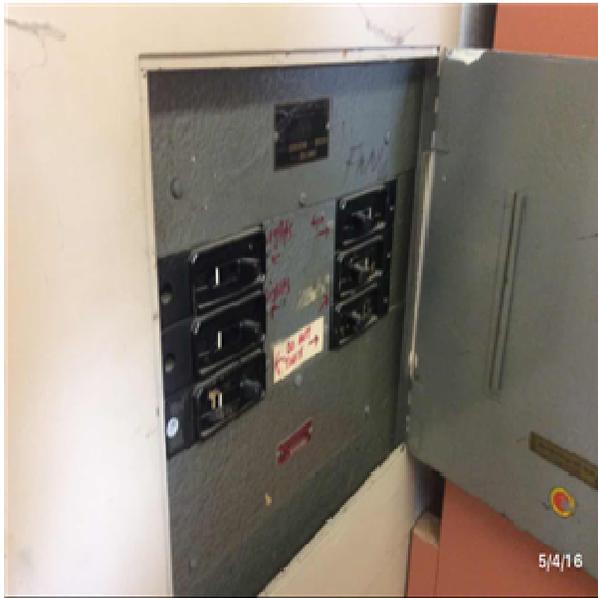
D5012 Low Tension Service & Dist:- View of Panelboard -  
120/208volts, 60amp

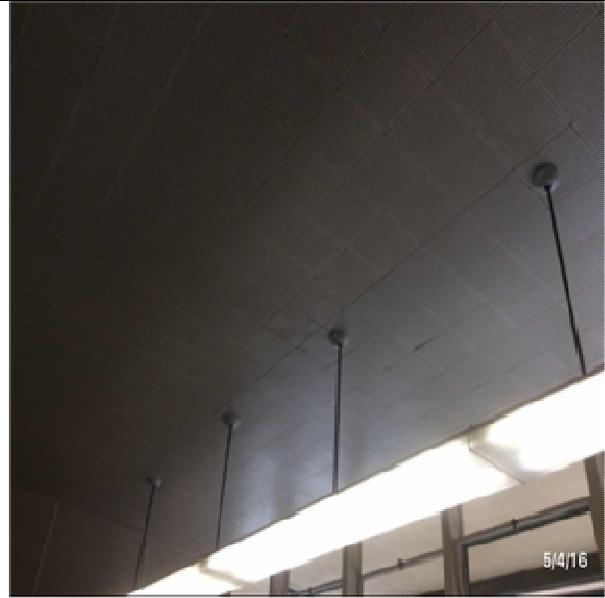
D5022 Lighting Equipment:- View of Interior Light Fixtures -  
Fluorescent
